Creegan+D'Angelo  
INFRASTRUCTURE  
ENGINEERS

Petaluma and Santa Rosa Railroad Trestle  
Limited Structural Assessment  
Petaluma, California

November 26, 2007

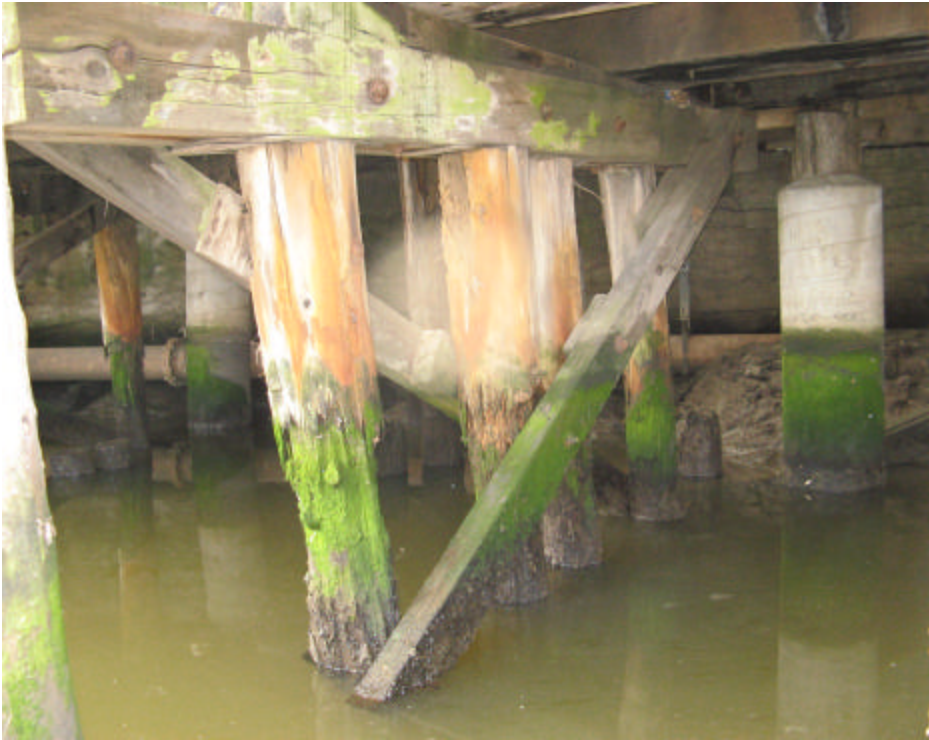
Visual inspection revealed that most of the piles have suffered some loss of cross section. Piles were categorized visually as "Good," "Fair," "Poor," and "Beyond Poor;" refer to Table 4 at the end of the text for a summary of pile visual ratings, and Drawings 2 through 5 at the end of the report for a graphic representation of the visual rating of the piles. In general, piles classified as good suffered no apparent damage or section loss. Piles identified as fair suffered section loss up to approximately two inches from the original surface of the pile. Piles identified as poor suffered section loss greater than approximately two inches, to approximately three inches from the face of the pile. Piles that appeared to exhibit a severe amount of section loss, including having holes that passed through the entire cross-section, were categorized as beyond poor. There were four piles that were rated "good," two rated "beyond poor," 118 rated "fair," and 49 rated "poor." Pile section loss appeared to occur near the top of the range of high tide (high tide as observed during the dates of the field inspections, which fluctuated as much as 6.1 and 6.3 feet on August 27 and August 28, 2007, respectively). Section loss was typically characterized by "necking down" to the minimum diameter and then transitioning back to a larger cross section. The condition of a typical pile with cross-section loss is shown in Figure 5 below.

Figure 5: Typical Pile Cross Section Loss – Bent 6 (nearest pile rated “fair”)  
Beyond the bent is a concrete pile associated with the deck adjacent  
the Mill building. Bent 6 is a four-pile bent.

Load-bearing piles in general exhibited some section loss, generally less than three inches from the surface, for a loss in diameter of up to six inches. For a twelve-inch diameter pile, a two inch loss all around amounts to a loss of approximately 55 percent of the cross-sectional area, and a three inches loss all around amounts to a loss of 75 percent. However, the remaining section of pile at the location of section loss registered resistance on the resistograph and appears able to carry load. The tops of some piles registered low resistograph readings, suggesting decay and loss of load

Most structural piles have experienced section loss, and some have experienced deterioration at the tops of some piles. As indicated in the demand/capacity ratio tables, some piles with reduced cross section will be inadequate for pedestrian or trolley load. Replacing an individual pile, or two or more piles within one bent, is challenging because there is not sufficient clearance to drive new piles between existing piles. It will likely not be possible to remove existing, damaged piles and install new ones in the same location for a number of reasons, as follows: 1) it may not be possible to completely remove existing piles. The piles may break during pulling, or there may be significant tension resistance such that it is not cost effective to mobilize equipment to remove them, and 2) piles are typically driven into undisturbed soil or rock strata. Driving piles into an area where there was an existing pile may compromise the capacity of the new pile. Accordingly, new bents can be constructed between existing bents in locations where existing piles are inadequate. Alternatively, it may be possible to add reinforcing steel and concrete around a damaged pile to repair it (concrete jacket). The tops of piles that have experienced end-grain decay will require repair, which could involve removing the

top of the pile and inserting an additional cap beam. The cap could be limited to the damaged pile, or extend over several damaged piles if they are adjacent to each other. Lastly, the tops of a number of piles do not fully support the bent caps, as the tops are not level; shimming caps will be required to ensure an adequate bearing surface for the bent caps.

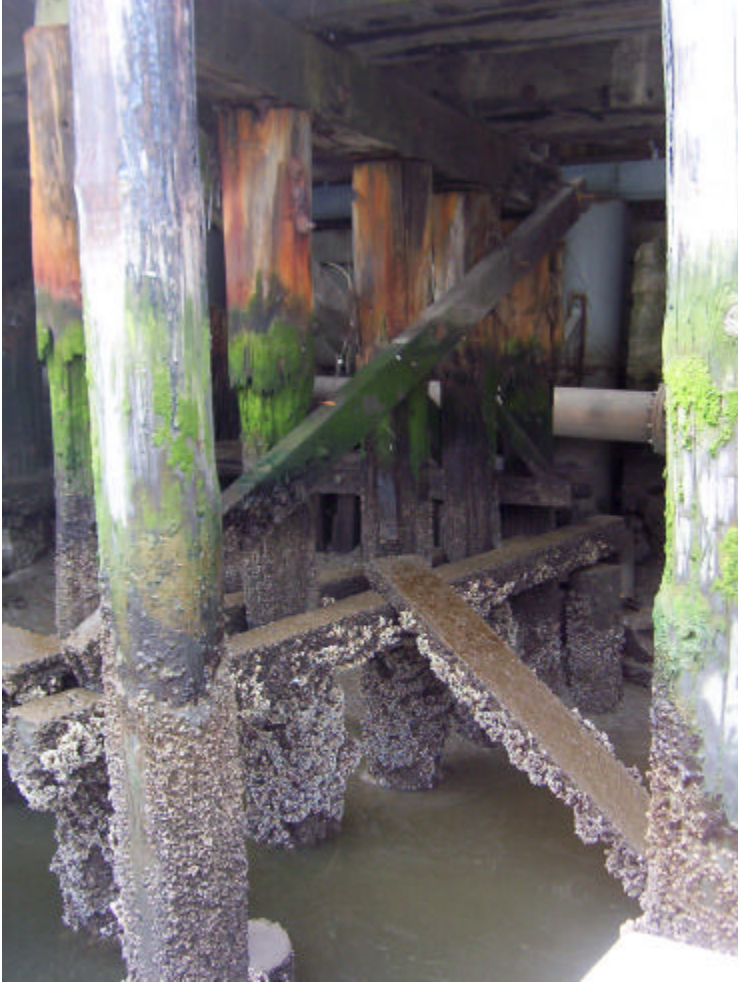
It should be noted that the majority of piles were not immediately accessible to the observers, and as such the visual evaluation was carried out from the shore or the dock. Accordingly, these classifications should be understood to be a rough, quantitative evaluation made from as far as 15 to 20 feet away. Additionally, while some of the piles were visible from the mud line to the bent cap during low tide, others were not; that is, portions of some of the piles were submerged, even during low tide, and the entire pile was not visible. Piles were not visually inspected below the mud line. The lower portions of many piles that were exposed only at low tide exhibited a significant degree of marine growth, as shown in Figure 6 below.

Figure 6: Typical Marine Growth (Bent 16)

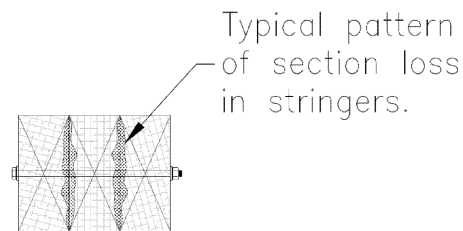
Resistograph readings of stringers revealed that while these members appeared sound from the exterior, there was some decay at the interior surfaces where the individual 7.5" X 18" stringers are sistered together, as shown in Figure 7. It is likely that water travels down the joint surface between stringers and does not evaporate, providing an environment for decay. The Resistograph readings suggest that up to several inches of the interior stringer member may be decayed at each interface. Incision marks typical of pressure treating were visible on some of the stringers.

Figure 7: Typical Stringer Damage

In one location, sounding (striking the stringer with a hammer, and listening to the sound of the impact, and qualitatively gauging the rebound of the hammer) performed by Kevin Flynn indicated a potential hollow spot beneath the face of a stringer that visually appeared undamaged. Multiple strikes with the hammer broke through the face of the stringer to wet, decayed wood.

Bent caps appeared to be sound, and unless future testing and inspection indicates otherwise, it is anticipated that these members are adequate. Stringers exhibited decay at the inner 7.5"X18" member, and at the interfaces of this member with the outboard members. This deterioration will continue. While the calculations indicate that the stringers are adequate for the pedestrian load case, they are likely inadequate for the trolley load case. One method of repair would be to remove the rail and ties, remove and set aside the stringer components, and replace the stringer with a steel wide-flange section. Stringer components could be placed outboard of the steel to conceal it, but would not contribute to the load-carrying capacity. The wood stringer components could facilitate attaching railroad ties and outriggers to the stringers.
